Manhole Inspection Summary

Manhole # S170__015MH

Location Address: **509 christian st**

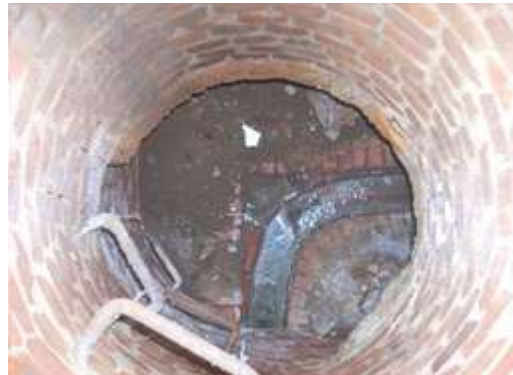
Top View

offset type 2

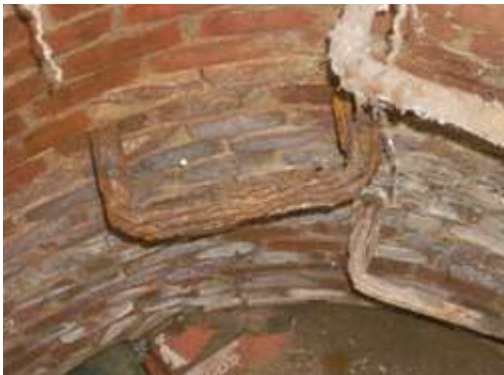
Defect 1

Count: **4** Missing: **0** ☒ **Corroded**

corroded steps

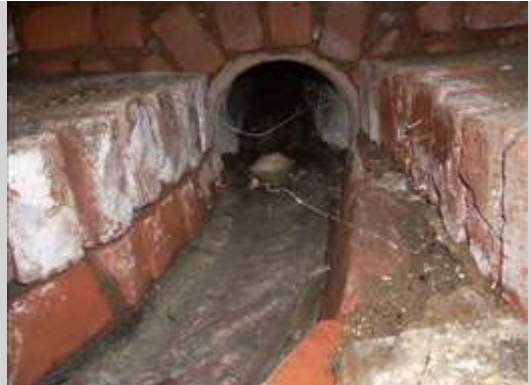
12 O'Clock Outflow

8 in. Circular Gravity Sewer
Pipe Out @ 12 O'Clock

Pipe Height: **7.2** (in.) Rod and Bar (Angled)
Pipe Material: **Clay** ☐ Pipe Lined
Invert Depth: **8.03** (ft.) Flow Characteristics: **Slow**
Deposits: ☒ None ☐ Mud ☐ Sludge ☐ Debris ☐ Grease
Silt Depth: **0** (in.) Deposits Extent:
Infiltration: **None** Pipe Seal Cond: **Sound**

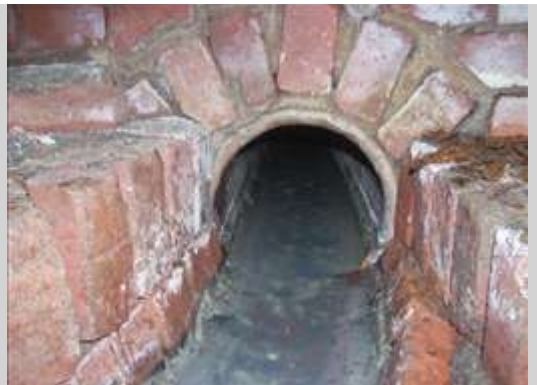
6 O'Clock Inflow

8 in. Circular Gravity Sewer
Pipe In @ 6 O'Clock

Pipe Height: **8.4** (in.) Rod and Bar (Angled)
Pipe Material: **Clay** ☐ Pipe Lined
Invert Depth: **7.90** (ft.) Flow Characteristics: **Slow**
Deposits: ☒ None ☐ Mud ☐ Sludge ☐ Debris ☐ Grease
Silt Depth: **0** (in.) Deposits Extent:
Infiltration: **None** Pipe Seal Cond: **Sound**
